DYNAMIC ANALYSIS GROUP LLC

BOCOUM (OUMAROU) V. DTNA-TRW

January 31, 2020

Nicholas J. Durisek, Ph.D., P.E.

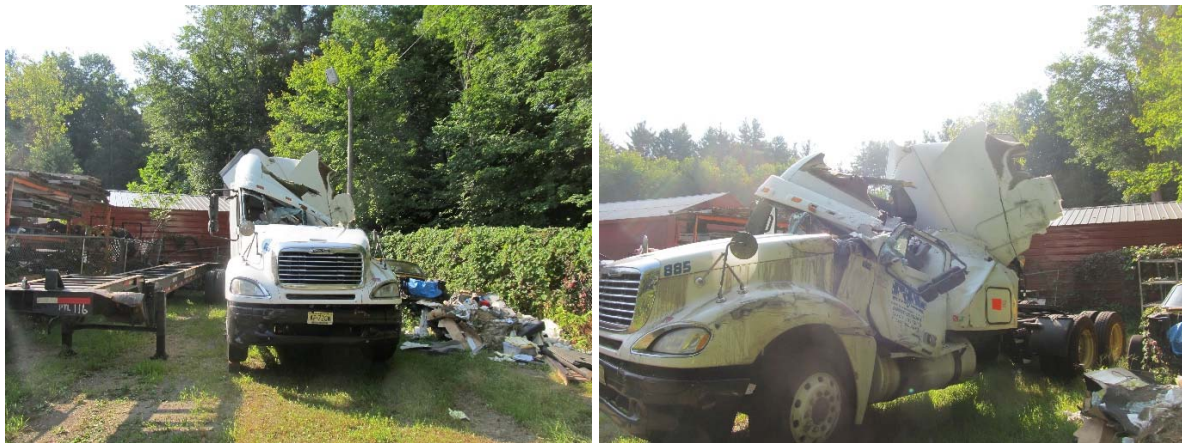
Figure 5. Crash involved Freightliner Columbia.

Damage to the upper left side of the vehicle was consistent with rollover contact with the asphalt roadway surface and guardrail. Front-to-rear roadway abrasions were present near the left-front fender area of the fiberglass hood. On the left side of the front bumper, roadway abrasions were present near the left-front tire, and the hood was misaligned with the front bumper. The front bumper was absent of evidence consistent with direct guardrail contact. The driver's door appeared bent and shifted. The cab and sleeper body panels were abraded and their structure was deformed and displaced. The driver's doorstep was bent, however the left side fuel tank appeared to be in its original position. The rear chassis structure appeared to be intact. Photographs showing the passenger's side and rear of the tractor were not available and no assessment of its condition could be made.

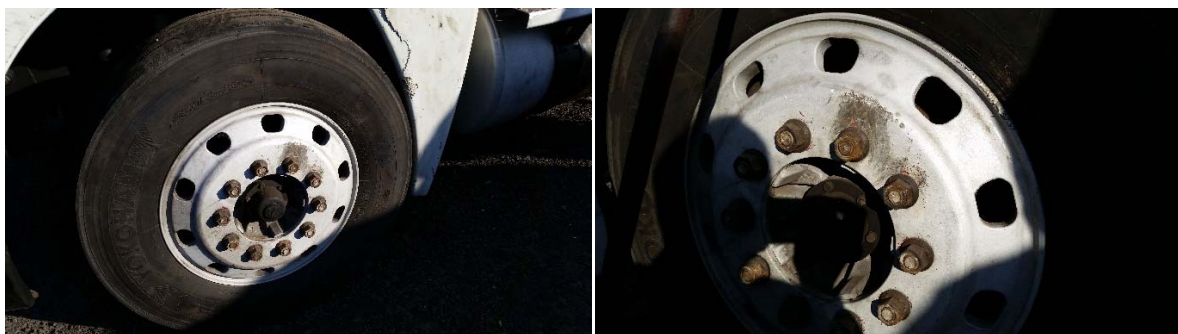
Contact damage was present on the left-front wheel and tire. Multiple abrasion patterns were present on the face of the rim near the wheel studs and wheel nuts; abrasions were visible on the wheel nuts. Abrasions present on the rim flange indicated contact forces from the outboard edge of the outer rim flange toward the center of the wheel. The left-front tire exhibited abrasions in the vicinity of the abrasions on the outer rim flange. The sidewall of the tire exhibited multiple abrasions in the same area as the contact damage on the outer rim flange. Figure 6 shows two photographs of the wheel and tire contact damage.

Figure 6. Left-front wheel and tire assembly from crash-involved Freightliner Columbia.

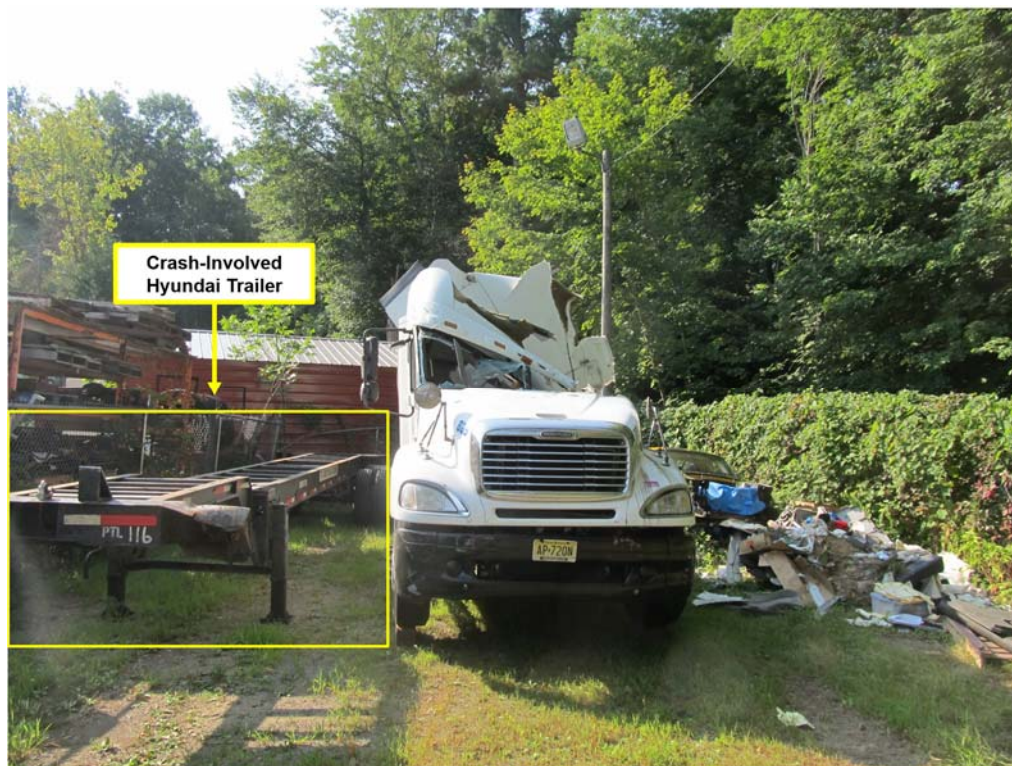
Figure 9. Crash-involved Hyundai trailer.

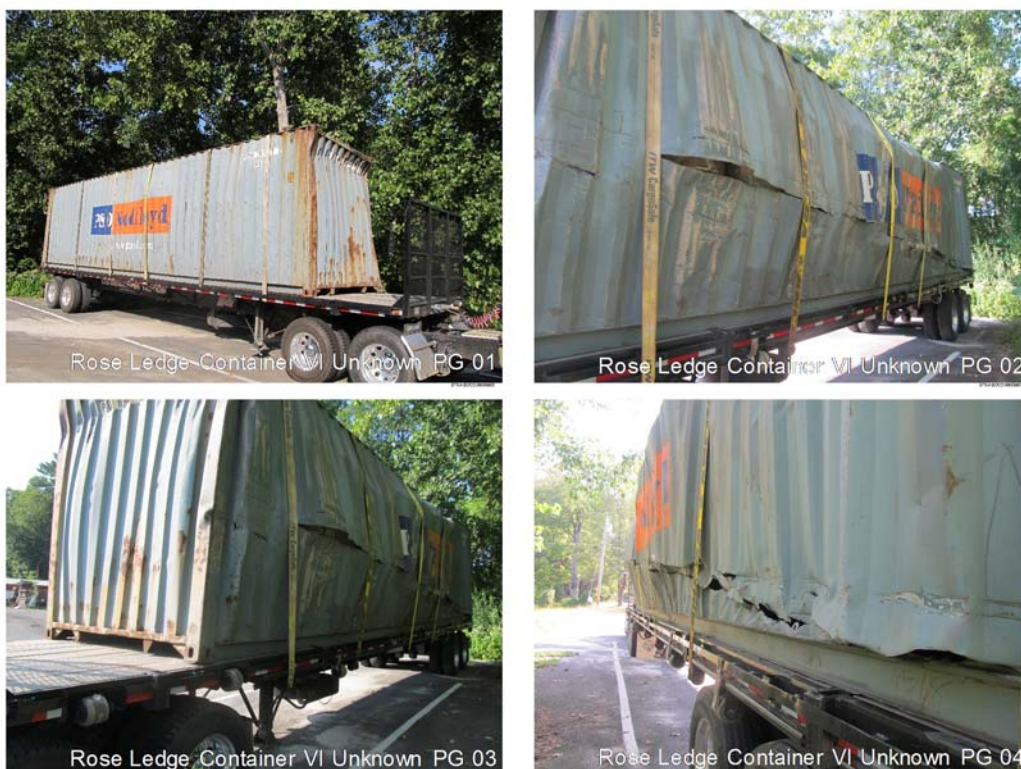
The trailer was carrying a forty-foot shipping container. The limited photographs showed that the left side of the container on the trailer contacted the guardrail and guardrail posts during the crash sequence. The sheet metal on the left side of the container was diagonally torn or cut from midway on the forward end of the left side of the container to the bottom corner at the rear of the container. Abrasions appeared to be present on the left side of the container as well. The forward facing side of the container near its top edge was deformed with evidence of narrow object contact damage. The recovery team invoice description stated that “the front of the trailer had impacted a 30 [inch] tree.”¹⁸ Figure 10 shows four photographs of the subject container from different angles. Approximately eighty-two rolls of paper were in the container at the time of the crash that reportedly weighed 43,898 pounds.¹⁹ Photographs of the container’s contents are shown in Figure 11.

Figure 10. Crash-involved trailer container.

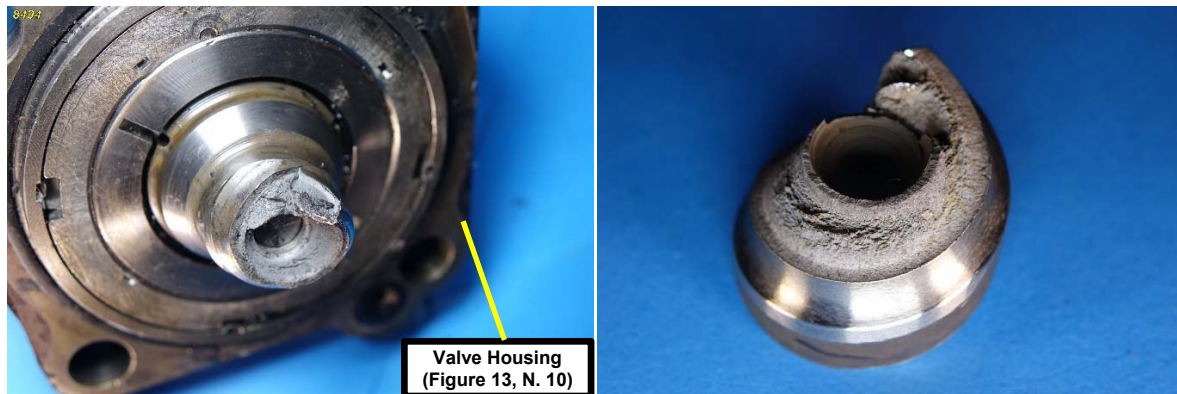
The worm screw was fractured at its end nearest the input shaft as shown in Figure 14. The fracture surfaces appeared uniform and were absent of post-fracture contact marks. No beach marks or signs of fatigue fracture were observed. Prior to my inspection, the worm screw had been cut into multiple pieces. The worm screw prior to being cut is shown in Figure 15. The helix bearing race exhibited deformation from high-force contact with the steel balls, or brinelling, on the side of the helix furthest from the input shaft. These marks were from significant axial impact forces applied to the worm screw in the direction away from the input shaft and valve housing (Figure 13, No. 10). The deformation from the loaded steel balls can be better seen on the segments shown in Figure 16. The impact load marks are consistent with the worm screw being put in tension.

Figure 14. Worm screw fracture surfaces (cut segment on right).

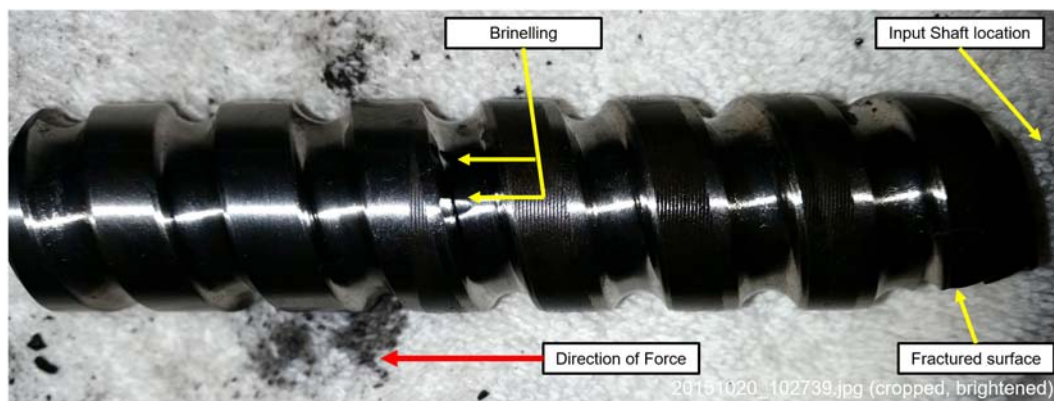
Figure 15. Worm screw with brinelling prior to being cut into multiple pieces.

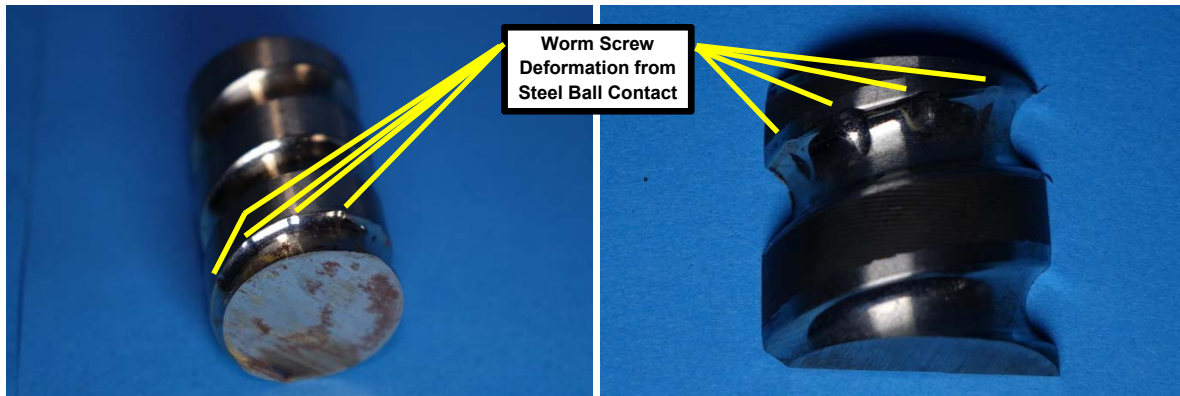
Figure 16. Worm screw deformation from steel ball contact.

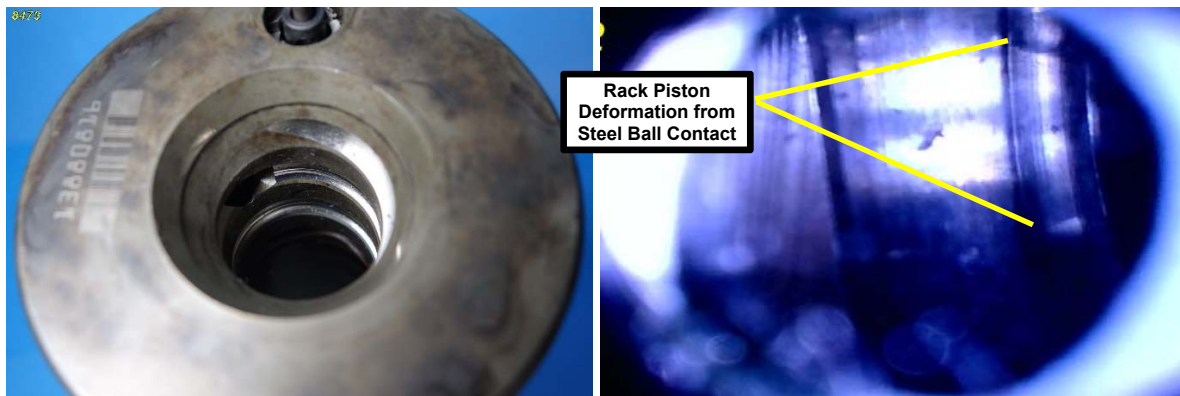
Localized deformation was also present on the helix bearing surface inside the rack piston, as shown in Figure 17. The deformation was not visible on the surfaces of the helix that can be observed from the opening of the rack piston, but the deformation from steel ball contact was visible on the surface nearest the opening with a small inspection mirror. I did not observe wear on the edges of the indentations on the worm screw or in the rack piston that would be consistent with the balls passing over the indentations repeatedly during use.

Figure 17. Rack piston deformation from steel ball contact on input shaft side.

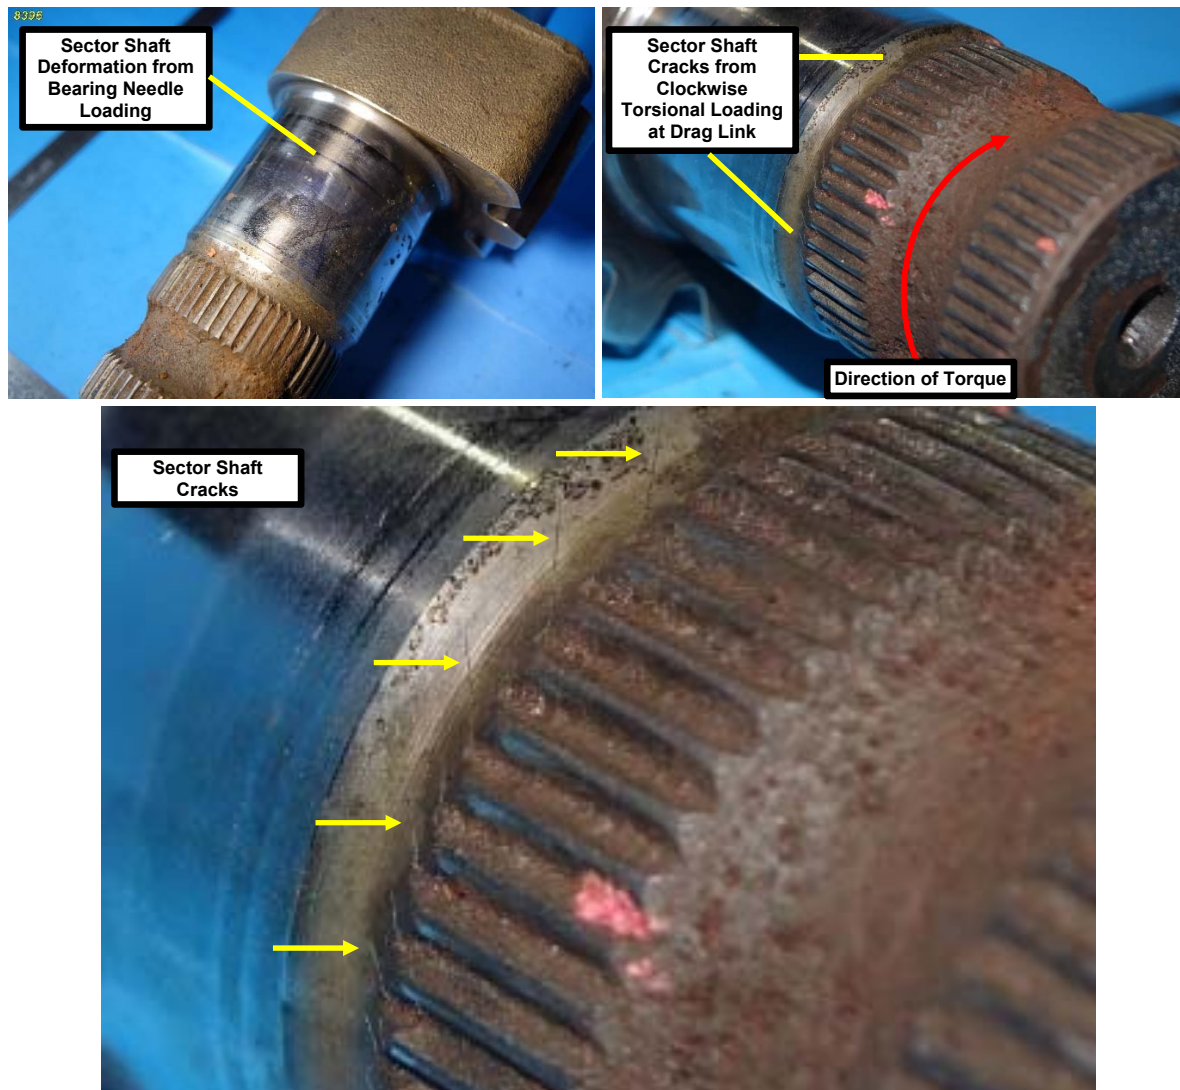
The sector shaft bearing race had localized deformation on the bearing race from the needle bearings and exhibited angled torsional cracks around the circumference of the sector shaft at the spline teeth of the drag link splines as indicated in Figure 18. The damage to the sector shaft is consistent with the sector shaft being loaded in a clockwise direction from a forward motion or force from the drag link, and this forward motion being resisted from within the steering gear. Given the geometry of the Freightliner steering linkage, the forward motion or clockwise rotation of the pitman arm is consistent with a forced left steer at the wheel end.

Figure 18. Sector shaft damage from loading and torsion.

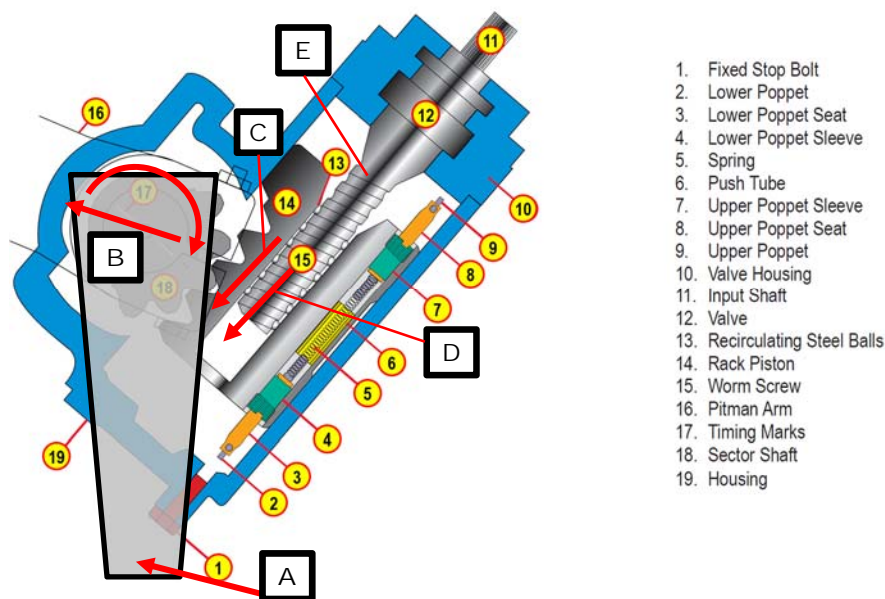
The damage to the steering gear components is consistent with loading from the pitman arm being pushed forward (A in Figure 19), consistent with a forced left steer at the wheel end. The forward forces at the end of the pitman arm likely resulted in a combined clockwise torsional loading and radial loading at the sector shaft (B), and through the gear teeth, forces were applied to the rack piston (C) in direction away from the input shaft. These forces were transmitted to the worm screw through the recirculating balls that were between the rack piston and worm screw resulting in a tensile load on the worm screw (D); torsional loading would also be present due to the helix geometry between the worm screw and rack piston. The described load path is consistent with all the damage documented to the steering gear assembly components and resulted in the fracture of the worm screw at E, indicated below. The physical evidence to the steering gear components indicate that higher than design loads were imparted to the steering gear assembly during the crash sequence.

Figure 19. Steering gear assembly load path determine from damage analysis.

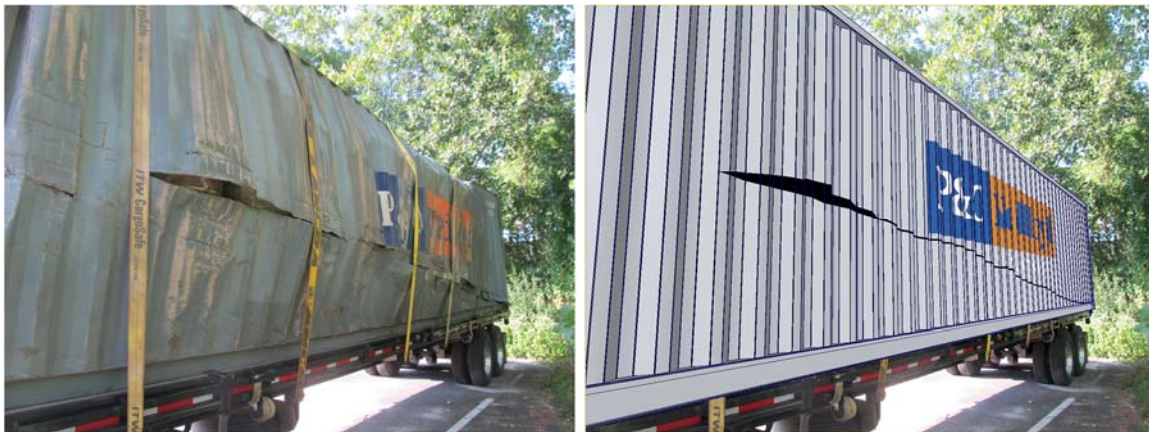
The trailer and container fell on top of the W-beam guardrail and asphalt roadway during the overturn. The sheet metal on the left side of the trailer's cargo container was diagonally torn or cut with damage being higher on the forward end of the cargo container, shown in Figure 20 next to a three-dimensional representation of the cargo container damage. Using the available photographs, the approximate area where the W-beam guardrail damage began was determined and the diagonal cut on the side of the trailer's cargo container was graphically aligned with the top of the guardrail as shown in Figure 21. The orientation of the cargo container on the guardrail indicated that the left-rear of the cargo container was likely first to contact the guardrail. No physical evidence indicated that the trailer wheel and tire assemblies initially contacted the W-beam guardrail structure; it is unlikely that contact between the trailer wheel and tire assemblies and the guardrail initiated the overturn.

Figure 20. Crash involved cargo container (left) and three-dimensional representation of crash involved cargo container (right).

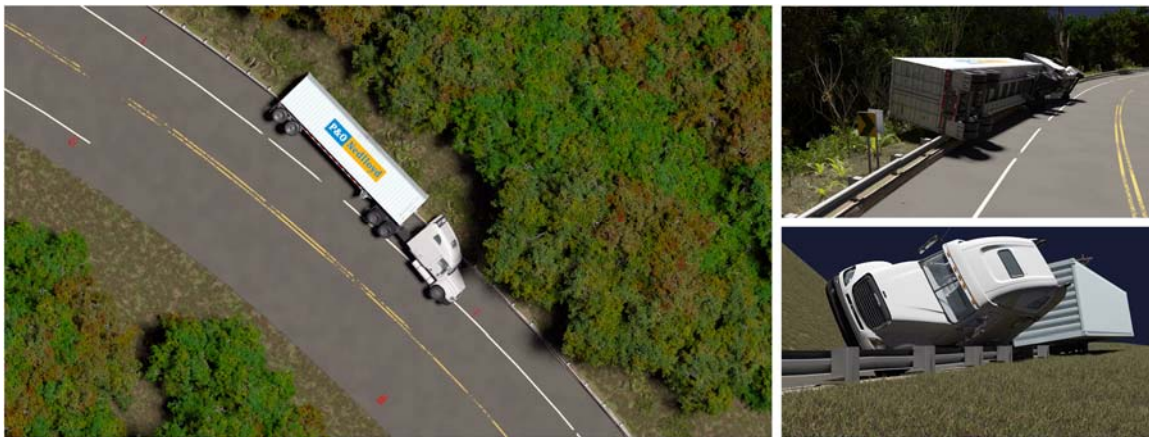
Figure 21. 2007 Freightliner Columbia 120 and cargo trailer area of contact with W-beam guardrail.

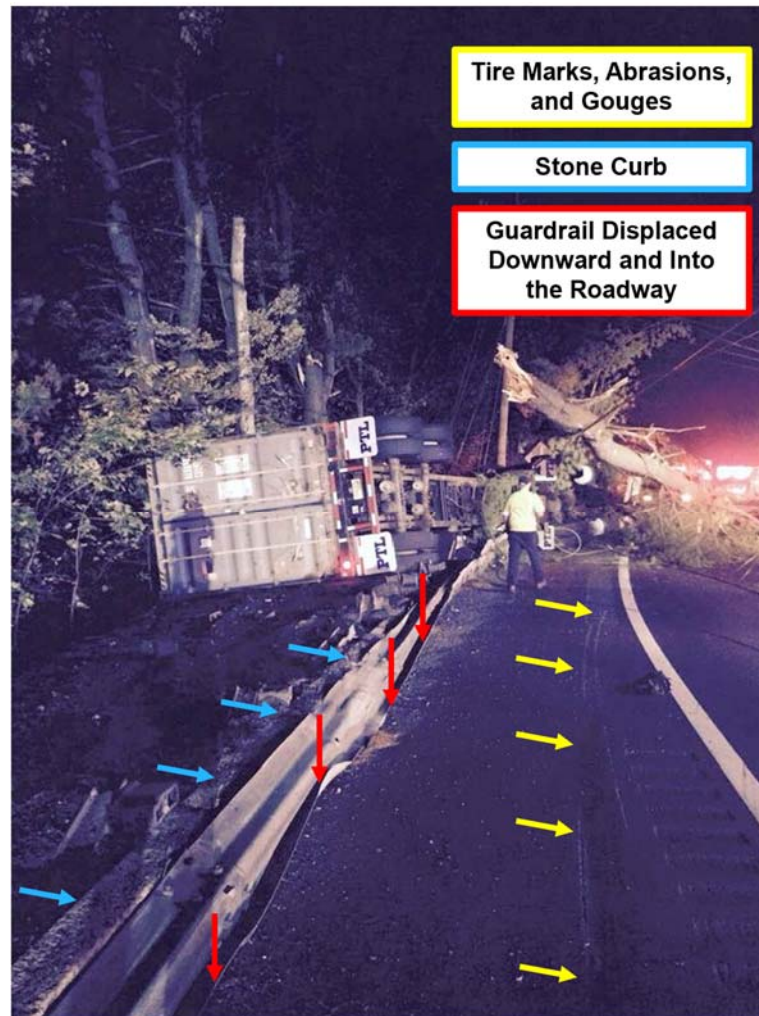
Figure 22. 2007 Freightliner Columbia 120 driver's side tire marks on roadway.

The location of the left-front tire mark indicated in Figure 22 is consistent with the vehicle's point of rest. The chassis and frame structure of the 2007 Freightliner Columbia 120 came to rest on the asphalt roadway in the MA-2 westbound shoulder. The upper cab and body structure

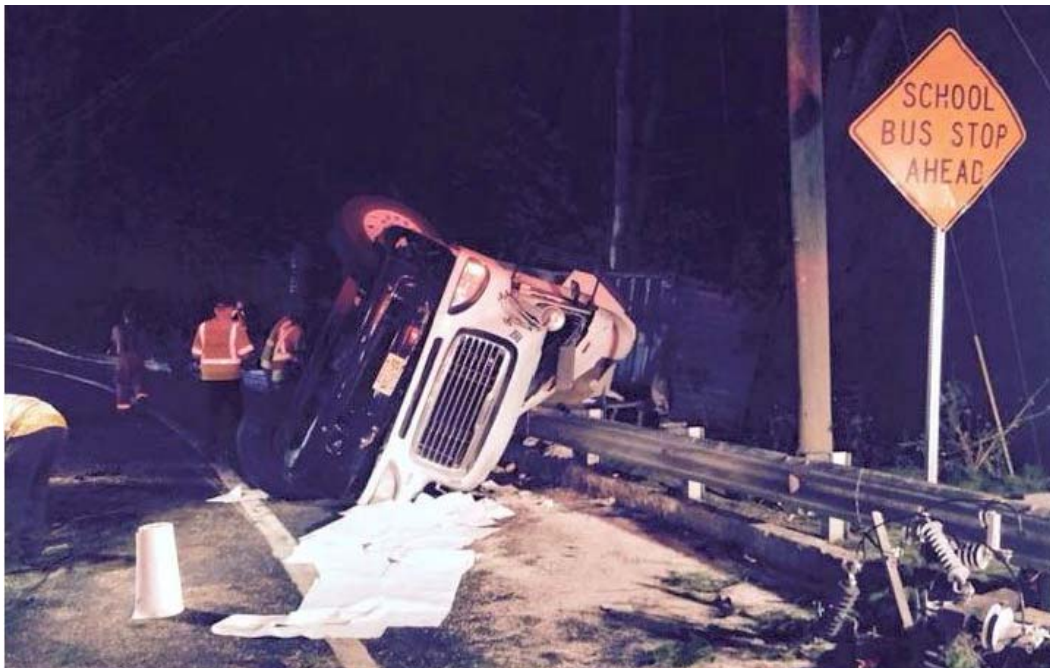
Figure 24. Freightliner tractor at rest with left-front wheel and tire on rumble strip turned left.

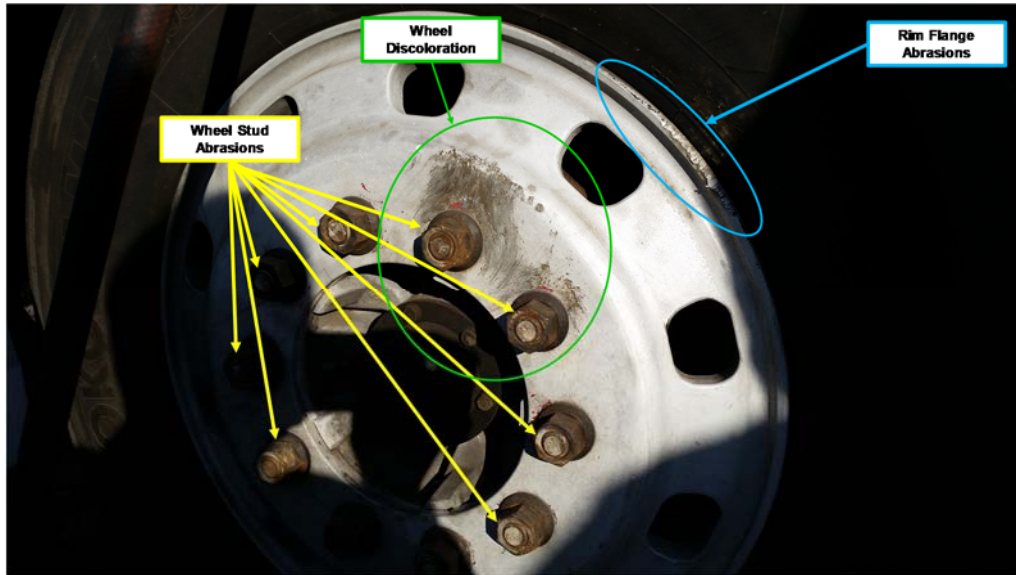
Figure 25. 2007 Freightliner Columbia 120 left steer axle wheel and tire assembly.

At rest, the steered wheels were turned left even though Mr. Bocoum steered right through a right turn. The physical evidence indicates that Mr. Bocoum had steering throughout his right steer and the Freightliner tractor responded to his steering inputs by turning right. The damage to the left side of the trailer cargo container and a lack of similar damage to the tractor, along with the other physical evidence, indicates that the trailer was likely tracking outside of the tractor at the time of overturn. The approximate distance between the locations where the cargo trailer container initially contacted the guardrail and the area of rest was likely between 110 and 120 feet. Figure 26 shows a three-dimensional graphic view of the crash sequence.

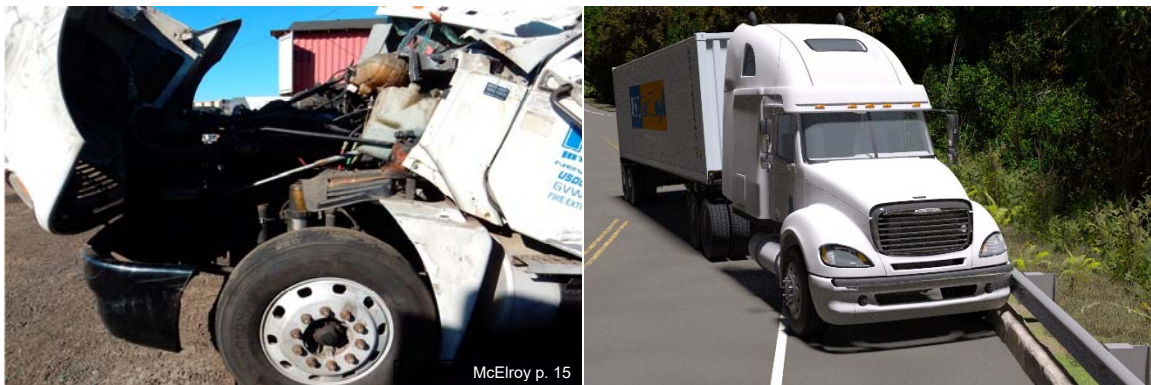
Mr. Bocoum testified that he drove straight into the guardrail. If he drove straight into the guardrail as he testified, damage would have been present to the left-front bumper and the guardrail damage would have been more than 100 feet upstream of the crash location. The lack of damage to the left-front bumper and a matchup between the representative bumper height and the guardrail are shown in Figure 27; if Mr. Bocoum would have driven straight into the guardrail, the left-front bumper would have been damaged. The lack of damage to the left-front bumper indicates that the Freightliner tractor was steered away from the guardrail and did not make contact with the guardrail. The location where the cargo trailer container first contacted the guardrail demonstrates that Mr. Bocoum steered his tractor to the right and successfully negotiated a radius.

Figure 27. Lack of Freightliner bumper damage and Freightliner bumper matchup with the W-beam guardrail.
